**Lincoln Hancock Restoration
Emergency Response Agreement – Inspection Report**

Name of Community: **Beach Arbor**

Address: 24 DeAllyon Avenue Hilton Head, SC 29928

Date: July 11, 2013

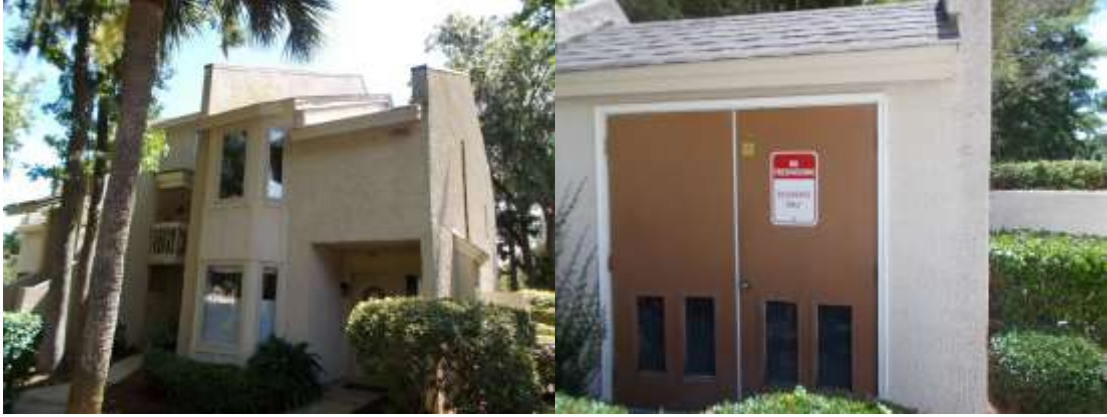
21. What type of roof system(s): Sloped asphalt shingle

22. Condition and age of roof: 10 + Years
