**Lincoln Hancock Restoration
Emergency Response Agreement – Inspection Report**

Name of Community: Village House

Address: 3 Wimbledon Court Hilton Head, SC 29928

Date: July 11, 2013

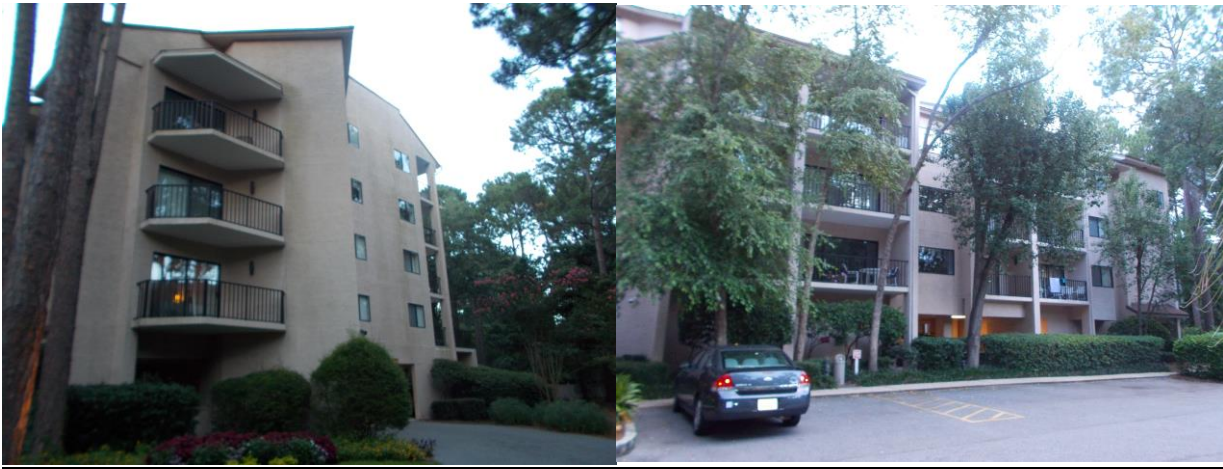
21. What type of roof system(s): Sloped Asphalt

22. Condition and age of roof: 10+ years
